**Flood Control Project Maintenance
Levee Inspections**

Fall 2019 Levee Maintenance Deficiency Summary Report

Sacramento River Basin

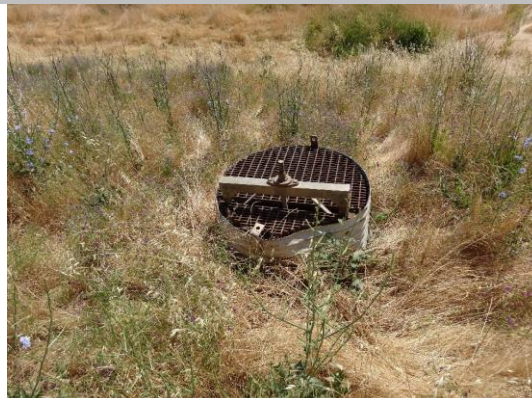
Photo 1 of 3 : UCIP_FA_2019_55208_22086.jpg

Comment Code						
Inspector Comment						
DS_ID:22631 FS_ID:55208 EP_NO: N/A Repair Type: Non-Urgent Crossing Status: Found UCIP Comments: 08/21/2019 Record remains Non-Urgent, due to limited inspection on the LS and missing permit. Dense vegetation on LS slope and toe prevented thorough inspection. Pipe description was updated with USACE O&M reference. (O. Magana - DWR UCIP)05/15/2013 Only a small section of head wall visible, almost buried. (P. Amatya - DWR UCIP) FIELD_STRUCT_DESC: 24-inch corrugated metal gravity drainage pipe through the levee, 12 feet below the crown. Slide gate in a 36-inch corrugated metal pipe (CMP) riser on the waterside (WS) slope. Concrete headwall at the landside (LS) toe. Pipe crosses under the channel. [Additional Reference(s): DWR Levee Log, 1993. USACE Sacramento O&M Manual, Unit 142 - Back Levee of Reclamation District No. 1001, June 1959, Revised 04 May 2018, 24-inch pipe (HLM 3.59)]. FS Date: 8/21/2019 12:57:00 PM

WS- fixed slide gate in CMP riser on levee slope.

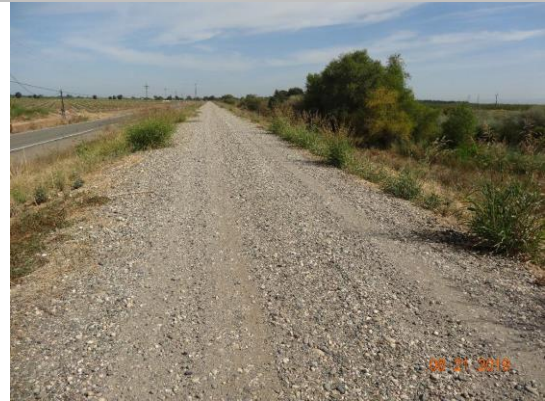
Photo 3 of 3 : UCIP_FA_2019_55208_81262.jpg

Comment Code						
Inspector Comment						
DS_ID:22631 FS_ID:55208 EP_NO: N/A Repair Type: Non-Urgent Crossing Status: Found UCIP Comments: 08/21/2019 Record remains Non-Urgent, due to limited inspection on the LS and missing permit. Dense vegetation on LS slope and toe prevented thorough inspection. Pipe description was updated with USACE O&M reference. (O. Magana - DWR UCIP)05/15/2013 Only a small section of head wall visible, almost buried. (P. Amatya - DWR UCIP) FIELD_STRUCT_DESC: 24-inch corrugated metal gravity drainage pipe through the levee, 12 feet below the crown. Slide gate in a 36-inch corrugated metal pipe (CMP) riser on the waterside (WS) slope. Concrete headwall at the landside (LS) toe. Pipe crosses under the channel. [Additional Reference(s): DWR Levee Log, 1993. USACE Sacramento O&M Manual, Unit 142 - Back Levee of Reclamation District No. 1001, June 1959, Revised 04 May 2018, 24-inch pipe (HLM 3.59)]. FS Date: 8/21/2019 12:57:00 PM

Overview of levee crown looking u/s towards pipe crossing.

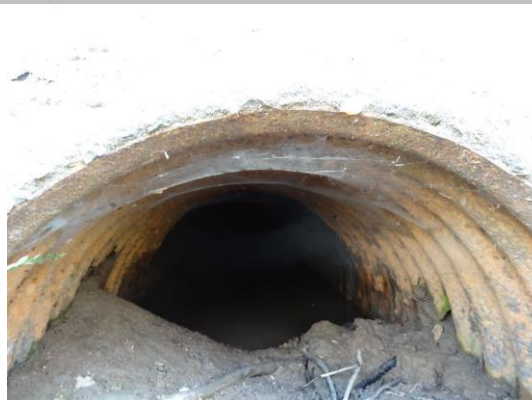
Photo 3 of 3 : UCIP_FA_2019_55209_22044.jpg

Item	DRAFT DWR UCIP Field Study		38.887003°	38.887003°								
			-121.524746°	-121.524746°								
DWR ID	22632											
Comment Code												
Inspector Comment												
DS_ID:22632 FS_ID:55209 EP_NO: N/A Repair Type: Urgent Crossing Status: Found UCIP Comments: 08/21/2019 Record remains Urgent, pipe wall at the inlet has failed. DMP internal video inspection has not been completed to determine extent of damage through the levee. Dense vegetation on LS prevented a thorough inspection. Record updated with USACE O&M reference. (O. Magana - DWR UCIP)10/30/2018 Photos of the pipe failure, visible from the LS inlet, were uploaded. Crossing remains Urgent due to the deteriorated condition of the pipe. Recommend internal inspection through the levee. (O. Magana - DWR UCIP)10/18/2018 Unable to access the LS toe due to muddy conditions. Assume no repairs have been done to this crossing to date. This crossing is part of DWR's Deferred Maintenance Project (DMP). Based on the photos taken in 2013 and 2016 the pipe section through the wall has missing pipe sections due to heavy corrosion. Recommend repair to avoid further deterioration of pipe section through levee. Levee is about 8-10 feet high. Crossing remains Urgent based on the deteriorated condition of the pipe on the LS. (O. Magana - DWR UCIP)07/13/2016 Same condition as last. Pipe heavily corroded and partially filled with debris and straw. (K. Fazel - UCIP) 05/15/2013:- mud/soil debris on LS pipe end.- highly corroded pipe in outlet.- may require video inspection or pressure test. (P. Amatya - DWR) FIELD_STRUCT_DESC: 24-inch corrugated metal gravity drainage pipe through the levee, 12.2 feet below the crown. Slide gate in a 36-inch corrugated metal pipe (CMP) riser on the waterside (WS) slope. Concrete headwall at the landside (LS) toe. Pipe crosses under the channel. [Additional Reference(s): DWR Levee Log, 1993. USACE Sacramento O&M Manual, Unit 142 - Back Levee of Reclamation District No. 1001, June 1959, Revised 04 May 2018, 24-inch pipe (HLM 3.93)]. FS Date: 8/21/2019 12:51:00 PM

LS- highly corroded and damaged CMP in concrete head/wing wall outlet

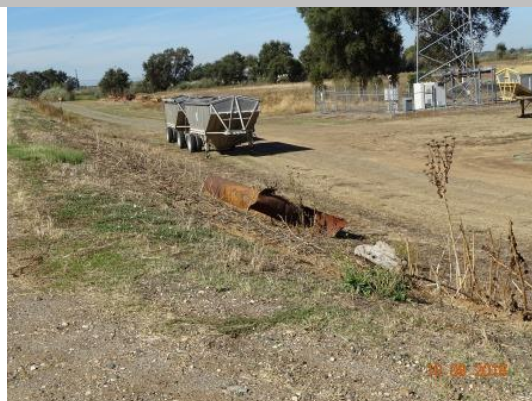
Photo 2 of 2 : FA_2019_RD1001_40_24_20190904_00009.jpg

LM Start	4.71	Rating **	M	Issue No.	24 (cont)	
LM End	4.71	Issue Type +	En	Location *	CR	
Category	Earthen Levee			GPS Latitude/Longitude		
				Start	End	
Item	Encroachments			38.896310 °	38.896310 °	
				-121.520674 °	-121.520674 °	
DWR ID	DWR_RD1001_06_f_2016_24					
Comment Code						
EQ : Equipment						
Inspector Comment						
Old piece of pipe still lying on landside levee slope, and equipment on levee crown, Fall 2019.

View of an old piece of pipe still lying on landside levee slope looking downstream. Fall 2018.
